## HOME INSPECTION REPORT

**10023 Sample Ave, Klamath Falls, OR.**

CLIENT'S NAME: Mr. & Mrs. New Homebuyer.  
DATE OF INSPECTION: May 12, 2006.  
TIME OF INSPECTION: 9:00 AM.  
INSPECTION #: N60512-1.

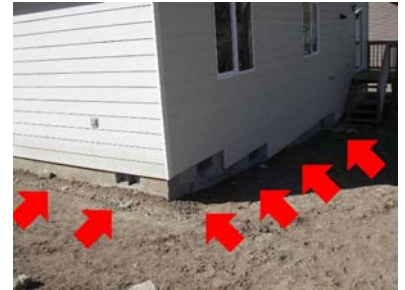
**LOT TYPE:** Gentle slope. NOTE: If soil stability or expansive soil conditions are a concern, please consult a Soils Engineer.  
**RAIN GUTTERS:** Gutters have not been installed.  
**FOUNDATION DRAINAGE:** Water marks in soil at right rear indicate that water runs parallel to the home toward the deck where is ponds against the foundation. Recommend correcting the grading around the home so water runs away from the foundation.

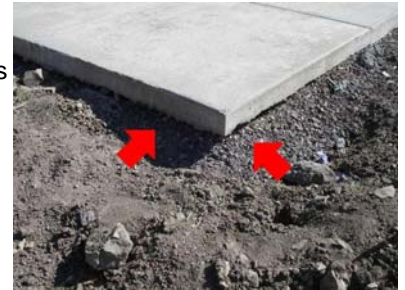
**DRIVEWAY:** Concrete-General condition is Good.  
**WALKWAYS:** Concrete-General condition is Good. Soil & gravel has washed out from under the front left corner of the front walkway and is no longer supporting the concrete in this area. This will significantly increase the chance of the concrete cracking in this area.

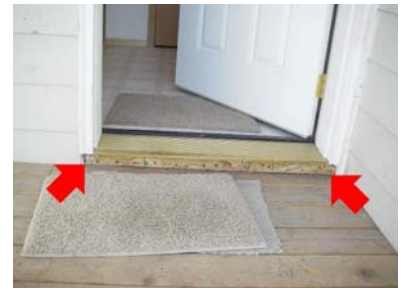
**SIDING CONDITION:** Good. Section of siding is missing beneath the front door.

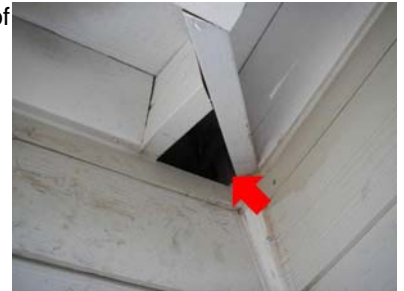
A hole in the overhang at the inside corner to the right of the front entry will allow birds to enter the attic. Recommend repair.

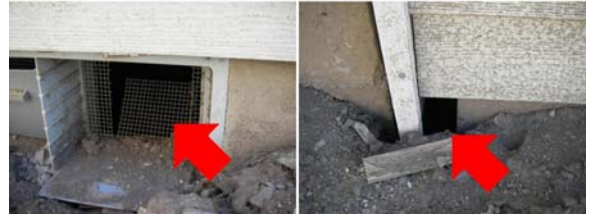
General condition is Good.  
Hose bibs were turned on and off again.  
A gap in the foundation at the left front corner between the porch and house can allow rodent entry. Recommend repair.  
Damaged foundation vent screen noted at left center. Recommend repair.

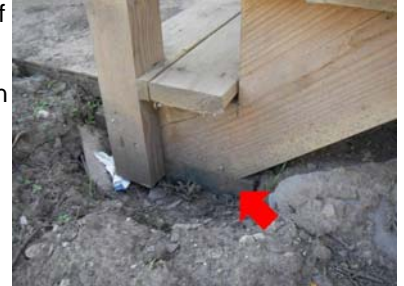
The non-treated stair treads extend to below the level of the adjacent grade. Although dirt is not currently in contact with the stringer, if the hole is filled in the earth to wood contact will significantly accelerate deterioration at the bottom of the stringers.

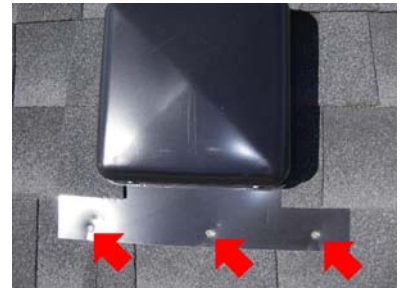
Roofing nail heads are exposed without the proper sealant covering: (30-40), Recommend proper sealing of the exposed nail heads by a licensed Roofer.

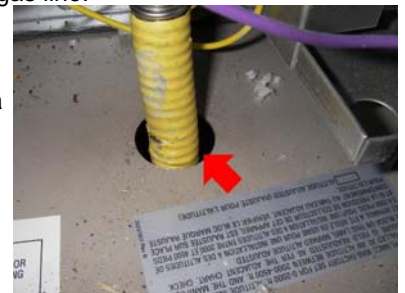
**FLEXIBLE CONNECTOR:** A flexible gas line is improperly installed through the furnace cabinet. It is recommended that solid gas line extend through the furnace cabinet then connect to the flex line. Recommend further evaluation and repair by a licensed HVAC technician.

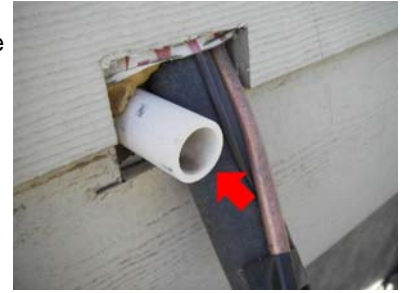
The drain line does not have an elbow on it's end and will allow water to run back down the outside of the pipe and into the wall. Recommend installing an elbow to allow the water to drip freely from the pipe.

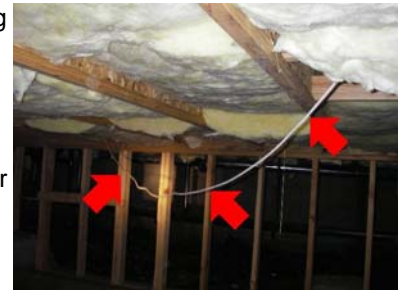
Two branch wire circuits are not properly supported in the crawl space. They appear to have been added after the fact.

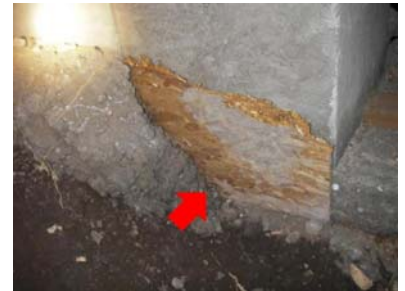
**REMARKS:** Small section of wood form board is still in place at the rear center of the pony wall footing.

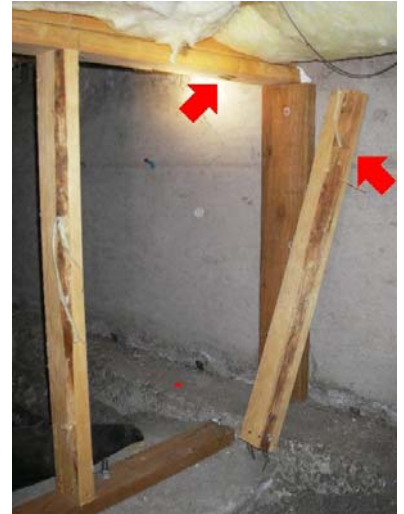
Pony wall. The right most pony wall stud has been removed. Recommend repair by a licensed contractor.

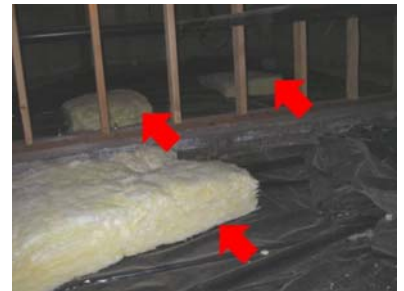
No.  
None was identified by visual examination.  
Oriented Strand Board.  
Yes. Underfloor insulation restricts viewing. Insulation has fallen down in a few places.
