HOME INSPECTION REPORT

151 Sample St, Klamath Falls, OR.

CLIENT'S NAME: Betty Homebuyer.
DATE OF INSPECTION: February 24, 2006.
TIME OF INSPECTION: 9:00 AM.
INSPECTION #: N60224-1A.

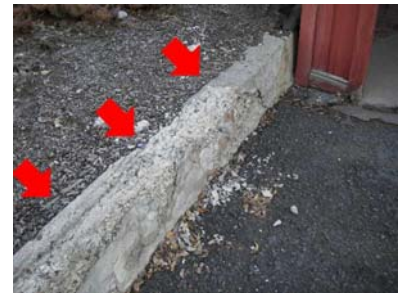
LOT TYPE: Gentle slope. NOTE: If soil stability or expansive soil conditions are a concern, please consult a Soils Engineer.
RETAINING WALLS: Retaining wall on the left side of the front driveway is deteriorated.

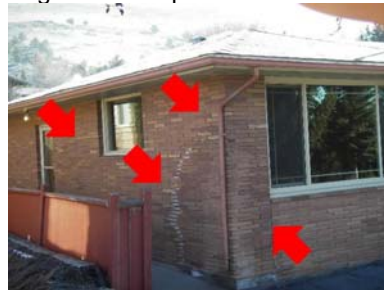
Staining and efflorescence on the brick at the left front corner indicates the downspout is leaking at its joints. This downspout is also draining near the foundation and has caused the foundation to settle in this area as evidence by the cracks in the brick on the left side between the door and window. Route downspouts away from the building to improve drainage.

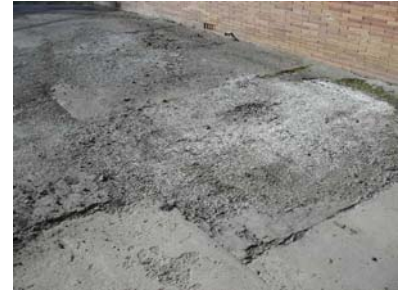
Front: Asphalt-General condition is Fair. Surface deterioration noted in some areas.
Rear: Concrete, General condition is Poor. Surface condition is: at least 50% of the area shows surface deterioration.

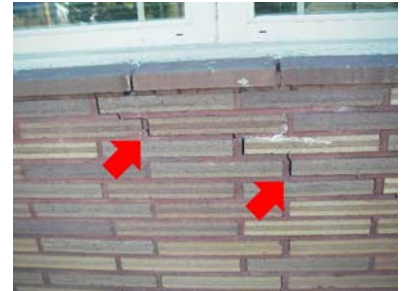
Settling cracks noted in the brick under the large window at the front right and on the left side between the door and window. Both cracks appear to be related to roof water draining near the foundation.

STRUCTURAL CONDITION: The overall structural condition is Good. Evidence of settling was observed in the brick work at the left front corner and under the large window at the right front. Refer to crawl space section for information about termite infestation and Dry Rot damage to the floor framing.

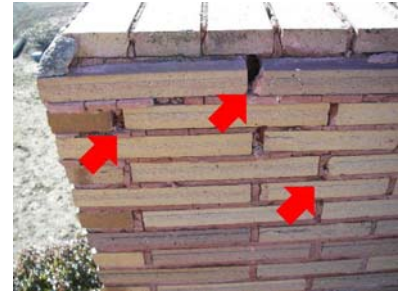
CONDITION: Fair, Repairs are needed.
MATERIAL: Brick and Mortar, Some of the bricks are loose. The mortar is deteriorated in some areas. Recommend repair by a qualified licensed mason.

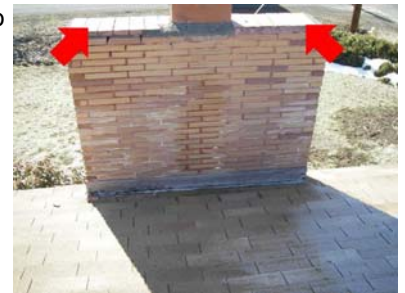
CHIMNEY CAP: A chimney cap is not installed, but it is recommended to prevent water entry and damage to the chimney.

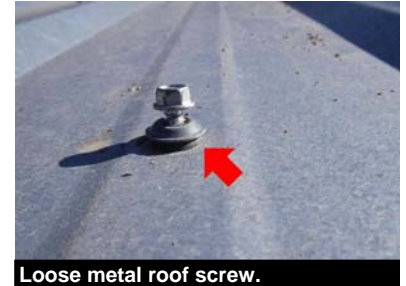
GENERAL CONDITION: Good.
LOCATION: Rear. Attached.
ROOF CONDITION: Good - Appears serviceable.
FLOOR CONDITION: Many of the metal roofing screw are loose. Loose screws increase the chance of leakage.

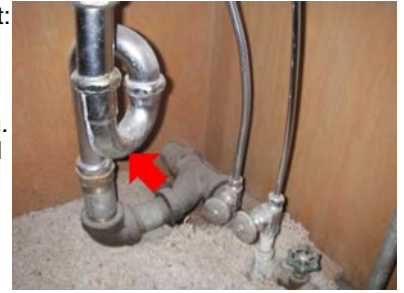
The following conditions were noted at the sink & faucet: Low water pressure / flow. The drain is very slow and leaks. The sink drain is improperly installed with an S-trap instead of the recommended P-trap and proper venting. The hand sprayer type faucet is not functioning. Recommend further evaluation and repair by a licensed plumber.

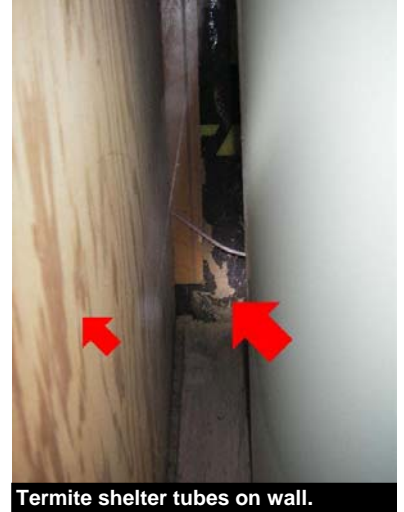
Termite shelter tubes observed on wall behind water heater. Unable to access this area to determine if any structural damage is present. Recommend further evaluation by a licensed Pest Control Operator and extermination as needed.

Termite shelter tubes on wall.

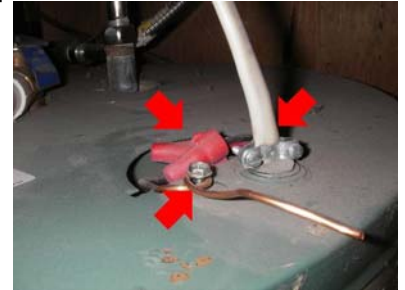
FLEX CONDUIT: The 220 volt electrical hook-up was run to the unit without the recommended flexible conduit = Recommend the safety upgrade. The junction box cover is missing. The ground wire screw is loose preventing proper grounding of the water heater.

Water Heater: The 220 volt electrical hook-up was run to the unit without the recommended flexible conduit = Recommend the safety upgrade. The junction box cover is not installed. The ground wire screw is loose preventing proper grounding of the water heater.

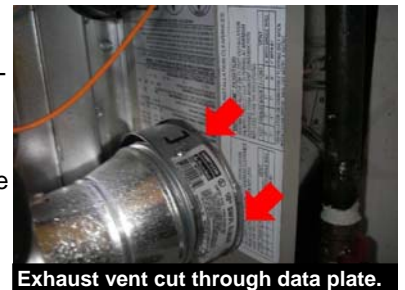
VENTING: The exhaust vent opening in the cabinet was field modified to a location not originally supplied by the manufacturer. I contacted Aire-Flo technical support (1-800-982-2333) for further information about field modifications of this unit and were informed that this is not an approved vent exit options. This may also indicate that the unit was installed without a permit. The field modification also removed a portion of the manufacturer's data sticker = unable to view serial number. Recommend further evaluation and repair / replacement as needed by a qualified licensed HVAC contractor.

Exhaust vent cut through data plate.

MECHANICAL CONDITION: The exhaust vent opening in the cabinet was field modified to a location not originally supplied by the manufacturer. I contacted Aire-Flo technical support (1-800-982-2333) for further information about field modifications of this unit and were informed that this is not an approved vent exit options. This may also indicate that the unit was installed without a permit. The field modification also removed a portion of the manufacturer's data sticker = unable to view serial number. Recommend further evaluation and repair / replacement as needed by a qualified licensed HVAC contractor.

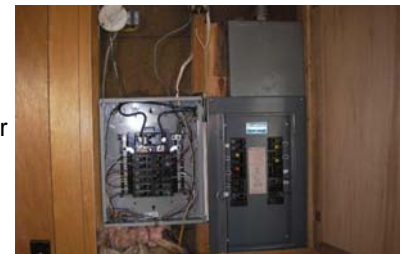
The wood paneling covers the bottom panel screw for the right (original) panel. This prevents removal and inspection of wiring inside right panel. This also prevents determining whether the left panel is wired as a sub-panel or a second main panel. If the left panel is wired as a sub-panel the grounding and neutral system may be compromised due to the bond strap that connects the neutral and ground bus bars and the neutral feed to the left panel is connected to the ground bus. Recommend removing the wood paneling from in front of the electrical panels and contacting a licensed electrician for further evaluation and repair as needed.

Wood paneling covers bottom of elec
